**Flood Control Project Maintenance
Levee Inspections**

Fall 2009 Levee Maintenance Deficiency Summary Report

San Joaquin River Basin

Reclamation District No. 0404 Boggs

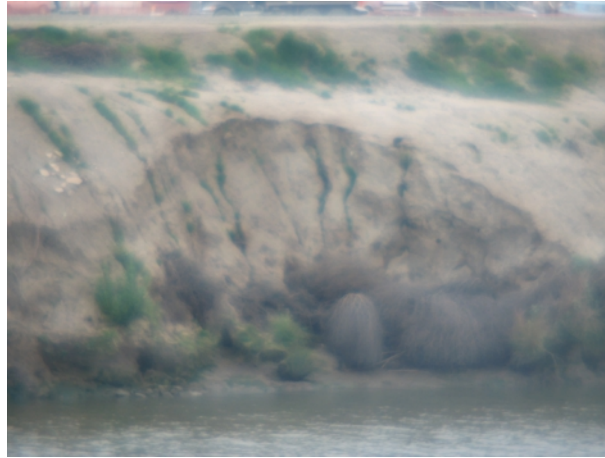
richard_20091104_28.jpg

Levee Mile Report Line	2
Start Levee Mile	0.24
End Levee Mile	0.27
Location	Water Side
Category	Earthen Levee
Item	Erosion / Bank Caving

Erosion from LM 0.24 to 0.27

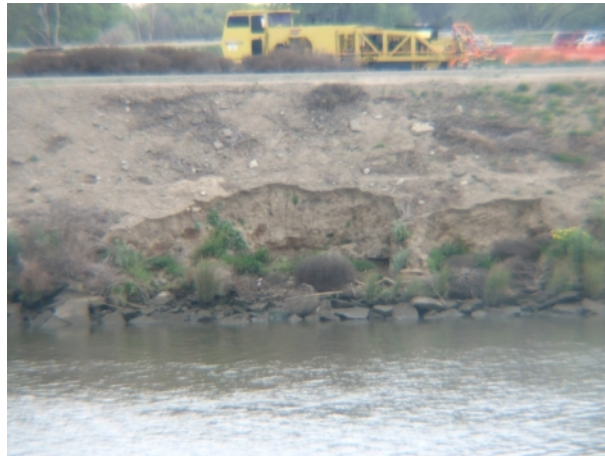
richard_20091104_29.jpg

Levee Mile Report Line	2
Start Levee Mile	0.24
End Levee Mile	0.27
Location	Water Side
Category	Earthen Levee
Item	Erosion / Bank Caving

Erosion at LM 0.27

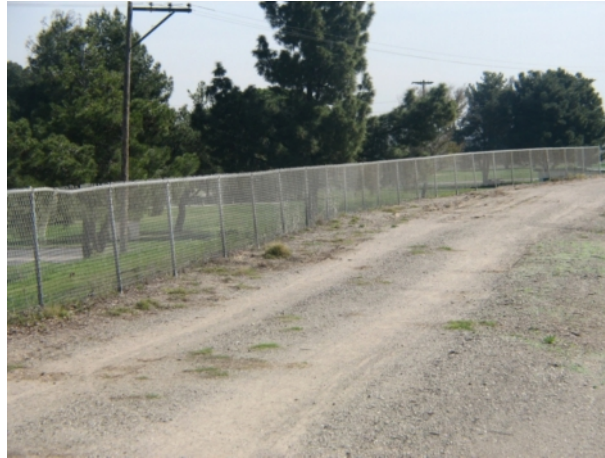
richard_20091104_31.jpg

6	1.47	1.52	Earthen Levee	Encroachments	LS	PO	Fences	37.918440 ° -121.296707 °	37.918517 ° -121.295763 °	6 Y
7	1.54	1.65	Earthen Levee	Crown Surface / Depressions / Rutting	CR	C	Add appropriate gravel or road base. Grade and compact.	37.918468 ° -121.295340 °	37.917843 ° -121.293470 °	5

Levee Mile Report Line	6
Start Levee Mile	1.47
End Levee Mile	1.52
Location	Land Side
Category	Earthen Levee
Item	Encroachments

Fence at landside shoulder from LM 1.47 to 1.52
